Heat Activated Repair Compound for Hot Surfaces

BELZONA
1251

Belzona 1251 (HA-Metal) is a single component system for the repair and protection of metal surfaces whilst in service.

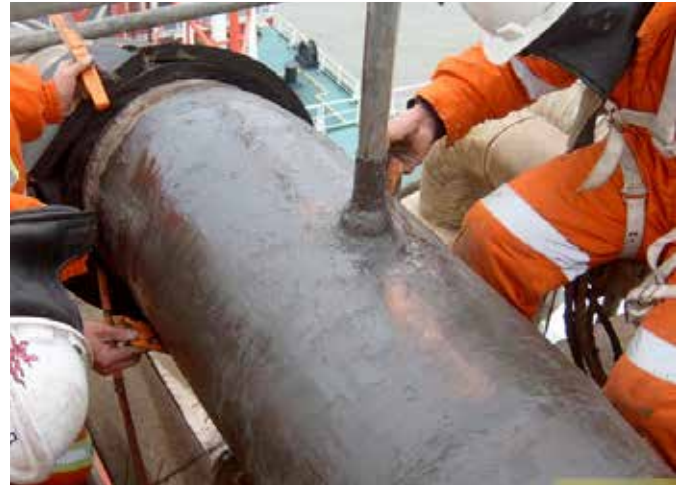
Oil and hot water pipeline repair

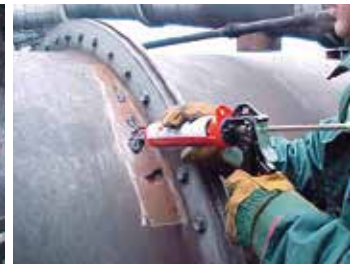
Pit filling

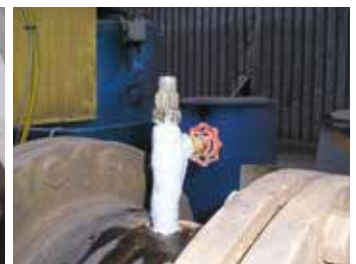
Leak sealing of pipework
