Water-Activated Leak Sealing Kit

Belzona 9631 is a leak-sealing kit containing a 5cm x 150cm / 2in x 60in fiberglass pre-impregnated wrap which is activated by water. Packaged in a hermetically sealed foil pouch, it is ready to use and does not require any measuring or mixing.

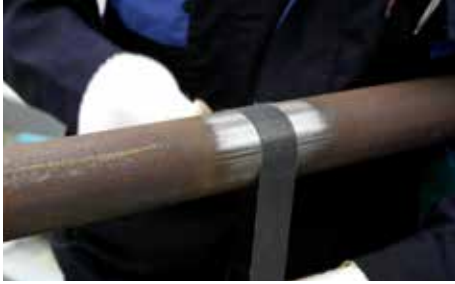
1. Roughen and clean surface

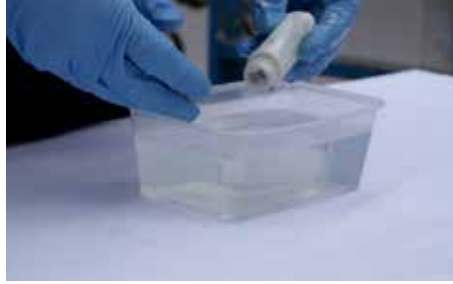
2. Soak wrap

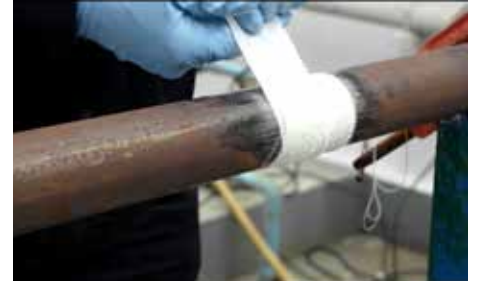
3. Apply wrap

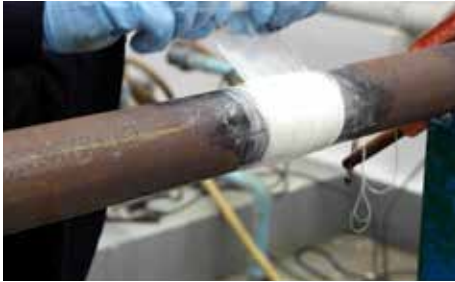
4. Apply film

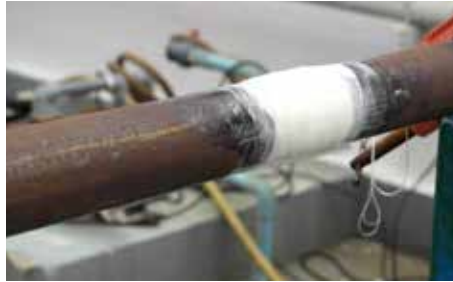
5. Application complete

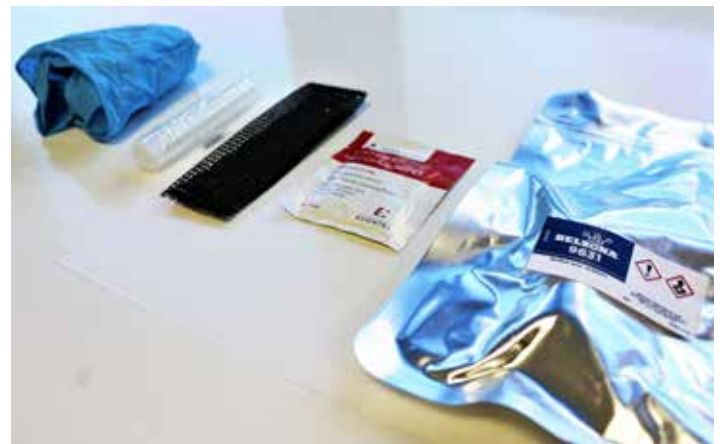
Kit contents (left to right) gloves, release film, roughing brush, cleaning wipes, water-activated wrap in a sachet

- Gloves
- Surface roughing mesh
- Cleaning wipes
- Water-activated wrap in a sachet
- Release film
